FIELD INSPECTION REPORT

DATES COVERED: June 3 and June 14, 2024

EVERFAB - SHOWER FIXTURE TESTING

9050 Porter Way SE

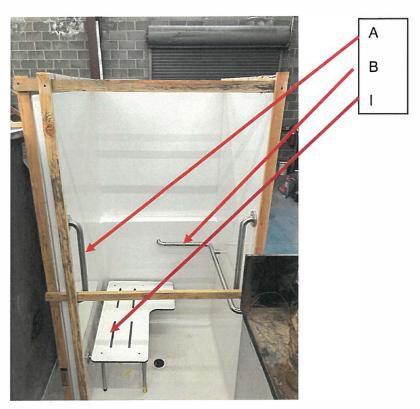
Photo 2 - 43" Shower Insert

- A Field Installed (screws) Vertical Bar, see attached Photo
- B Factory Installed (threaded with nuts and washer), see attached Photo

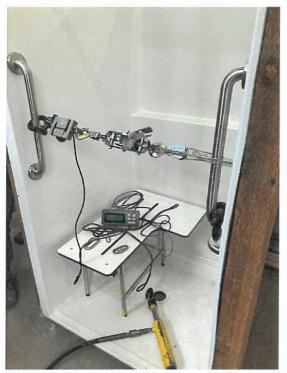
Photo 1 - Horizontal Test at Location A

Location	Element	Pull Direction	Load (lbs)	Displacement, Initial / Final	Return	Pass/Fail	
A*	Vertical Grab	Horizontal	250	30 1/8" / 29 ¾" 30 1/8"		Pass	
A*	Vertical Grab	Horizontal	500	30 1/8 / 29 1/8"	30 1/8"	Pass	
В	Horizontal Grab	Horizontal	250	34 ¼" / 34 1/16"	34 ¼"	Pass	
В	Horizontal Grab	Horizontal	500	34 ¼" / 33 5/8"	34 1/8"	Pass	
В	Horizontal Grab	Vertical	250	30 ½"/30 9/16"	30 ½"	Pass	
В	Horizontal Grab	Vertical	500	30 ½" / 30 9/16"	30 ½"	Pass	
ı	Folding Seat	Vertical	223	18 ½" / 18 1/8"	18 ½"	Pass	
ı	Folding Seat	Vertical	423	18 ¼" / 18"	18 ½"	Pass	
ı	Folding Seat	Vertical	523	18 ½" / 18"	18 ½"	Pass	
I	Folding Seat	Vertical	1810/2200	NA	NA	Cracked/Load to failur

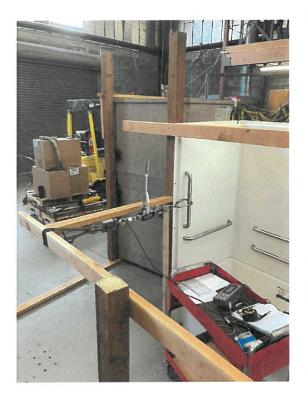
Photo 5 - Horizontal Test at Location C

Grab Bars Installed by Screws							
Location	Element	Pull Direction	Load (lbs)	Displacement, Initial/Final	Return	Pass/Fail		
С	Vertical Grab	Horizontal	250	26 ½" / 26 5/8"	26 ½"	Pass		
С	Vertical Grab	Horizontal	500	26 ½ / 27"	26 ½"	Pass		
E	Horizontal Grab	Horizontal	250	31 3/8" / 31"	313/8"	Pass		
E	Horizontal Grab	Horizontal	500	31 5/8" / 30 ¾"	31 5/8"	Pass		
F	Horizontal Grab	Horizontal	250	33" / 33 ½"	33"	Pass		
G	Vertical Grab	Vertical	250	37" / 36 ¾"	37"	Pass		
G	Vertical Grab	Horizontal	500	57 1/8" / 56 ½"	57 1/8"	Pass		
Н	Seat	Vertical	223	14 1/8" / 13 7/8"	14 1/8"	Pass		
Н	Seat	Vertical	423	14 1/8" / 13 5/8"	14 1/8"	Pass		
Н	Seat	Vertical	523	14 1/8" / 13 1/2"	14 1/8"	Pass		
D	Horizontal Grab	Horizontal	500	57 1/8" /56 ½"	57 1/8	Pass		
E	Horizontal Grab	Horizontal	480	29 ¾" / 30 1/8"	NA	Load to failure		
Floor Pan	Center Load	Vertical	620	.433" at failure	NA	Load to failure		
Floor Pan	Off-Center Load	Vertical	1567	.681" at failure	NA	Load to failure

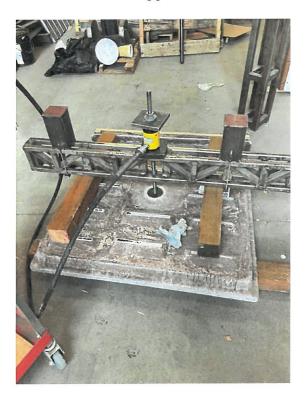
Photo 11 - Center load test of Floor-Pan

An independent floor-pan insert, model SP3937RFB was submitted to out laboratory for testing where two loads were applied at the center of the drain, see attached Photo 12 and 13 and another load was offset from center using a 4" circular steel plate with a ram assembly and bridge, See attached photo for test set-up. The table below indicates the displacement of load for the off-center floor-pan.

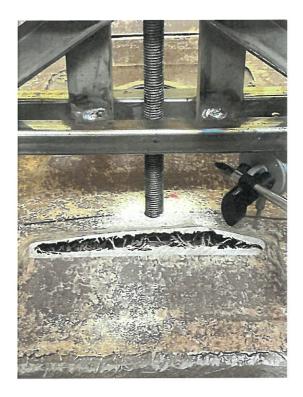
Photo 13 - Off-center load test failure location

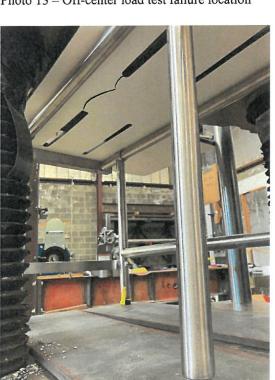
The folding shower seat was loaded in a hydraulic machine where a continuous load was applied to the top of the seat with a steel plate at 5" x 15" bearing in the center. The load was applied until a loss of pressure was observed in the machine, see attached Photo 14 and 15 for test set-up.

Photo 15 - Crack developed at failure of seat with 5" by 15" bearing plate

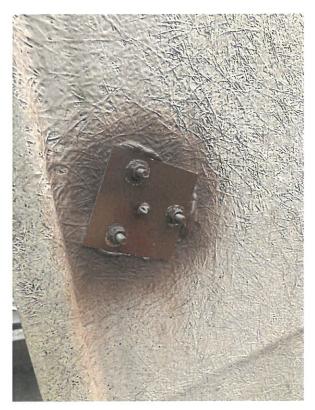
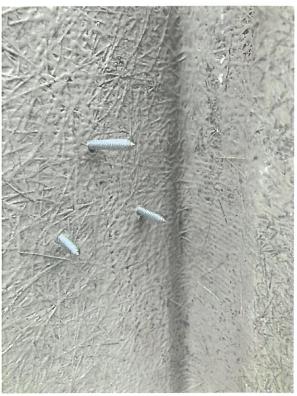
^{*} Field installed grab bar with #10 – 2 ½" Philips screw head;

Shop installed grab bars have nuts and bolts that are 1"long stainless steel with a ½" hex-head

Photo 16 - Factory installed nuts and washer Photo 17 - Field installed wood screws
