FIELD INSPECTION REPORT

DATES COVERED: June 3 and June 14, 2024

EVERFAB - SHOWER FIXTURE TESTING

9050 Porter Way SE

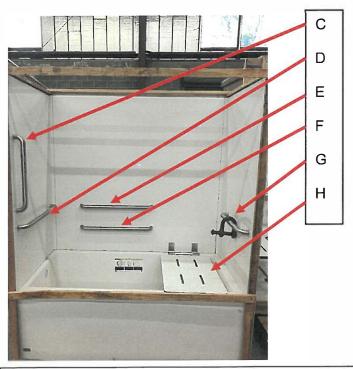
Grab Bars Installed by Screws							
Location	Element	Pull Direction	Load (lbs)	Displacement, Initial/Final	Return	Pass/Fail		
С	Vertical Grab	Horizontal	250	26 ½" / 26 5/8"	26 ½"	Pass		
С	Vertical Grab	Horizontal	500	26 ½ / 27"	26 ½"	Pass		
E	Horizontal Grab	Horizontal	250	31 3/8" / 31"	313/8"	Pass		
E	Horizontal Grab	Horizontal	500	31 5/8" / 30 ¾"	31 5/8"	Pass		
F	Horizontal Grab	Horizontal	250	33" / 33 ½"	33"	Pass		
G	Vertical Grab	Vertical	250	37" / 36 ¾"	37"	Pass		
G	Vertical Grab	Horizontal	500	57 1/8" / 56 ½"	57 1/8"	Pass		
Н	Seat	Vertical	223	14 1/8" / 13 7/8"	14 1/8"	Pass		
Н	Seat	Vertical	423	14 1/8" / 13 5/8"	14 1/8"	Pass		
Н	Seat	Vertical	523	14 1/8" / 13 1/2"	14 1/8"	Pass		
D	Horizontal Grab	Horizontal	500	57 1/8" /56 ½"	57 1/8	Pass		
E	Horizontal Grab	Horizontal	480	29 ¾" / 30 1/8"	NA	Load to failure		
Floor Pan	Center Load	Vertical	620	.433" at failure	NA	Load to failure		
Floor Pan	Off-Center Load	Vertical	1567	.681" at failure	NA	Load to failure

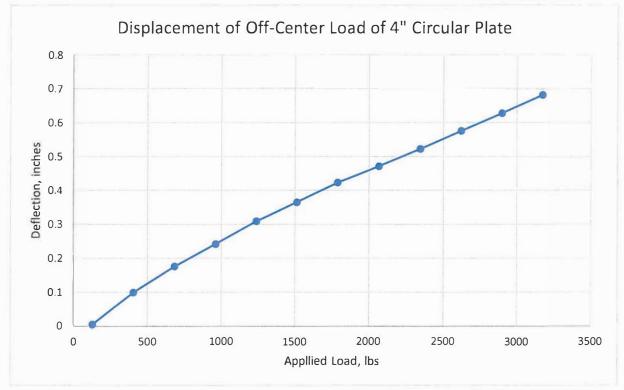
An independent floor-pan insert, model SP3937RFB was submitted to out laboratory for testing where two loads were applied at the center of the drain, see attached Photo 12 and 13 and another load was offset from center using a 4" circular steel plate with a ram assembly and bridge, See attached photo for test set-up. The table below indicates the displacement of load for the off-center floor-pan.
